UNNAMED TRIBUTARY TO HARMON CREEK, WASHINGTON COUNTY
PENNSYLVANIA

PHASE I INSPECTION REPORT

NATIONAL DAM INSPECTION PROGRAM

MICHAEL BAKER, JR., INC.

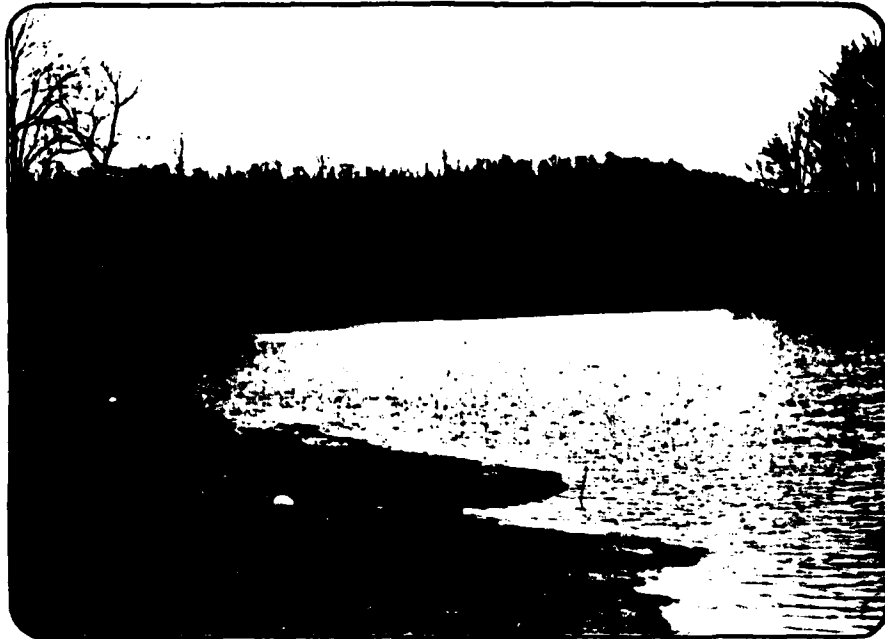
Overall View of Upstream Face of Dam from Reservoir Area

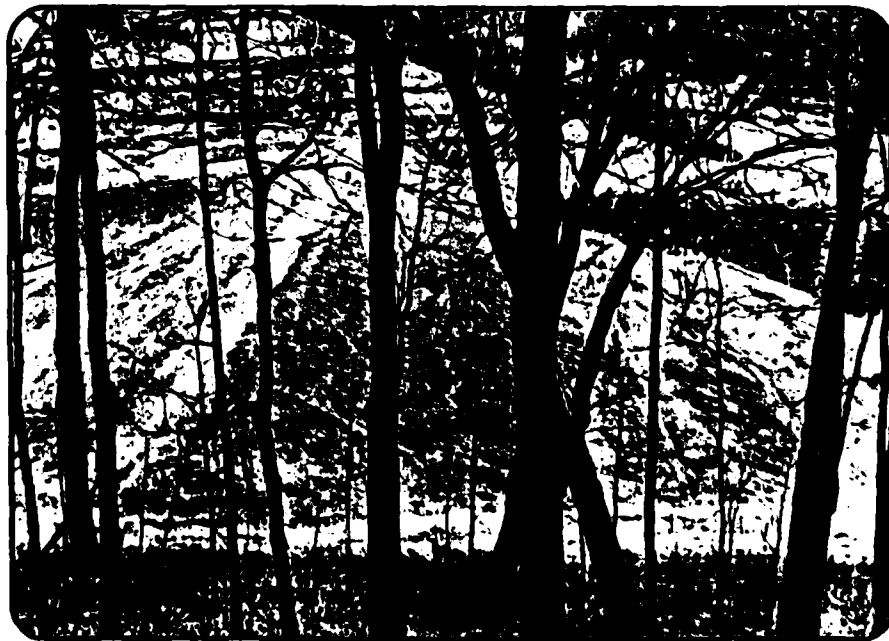
Overall View of Crest of Dam and Downstream Face from Right Abutment
